TECHNICAL NOTE NO. 457

THE AERODYNAMIC CHARACTERISTICS OF AIRFOILS
AS AFFECTED BY SURFACE ROUGHNESS

By Ray W. Hooker

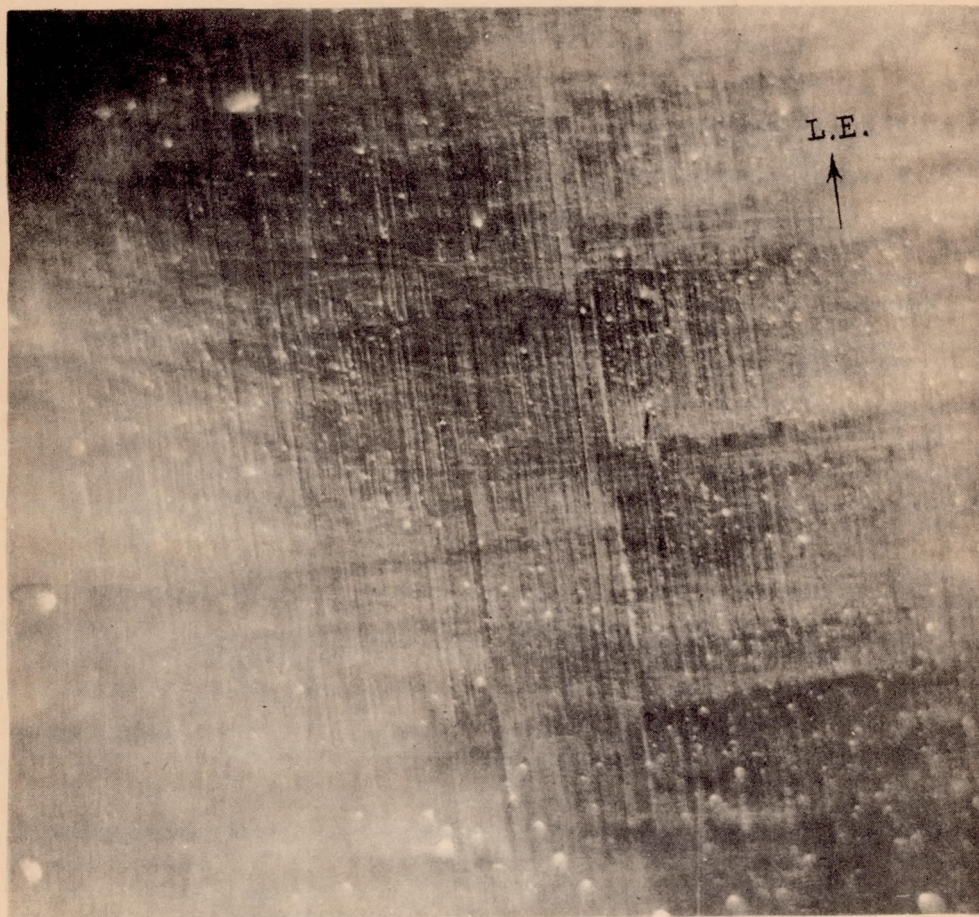
Figure 1.-Photomicrograph ($\times 15$) of the surface of the N.A.C.A.0012 airfoil as left by cutting tool of airfoil generating machine.
